Metallurgy of the *RMS Titanic*

Tim Foecke
Metallurgy Division
National Institute of Standards and Technology

Abstract

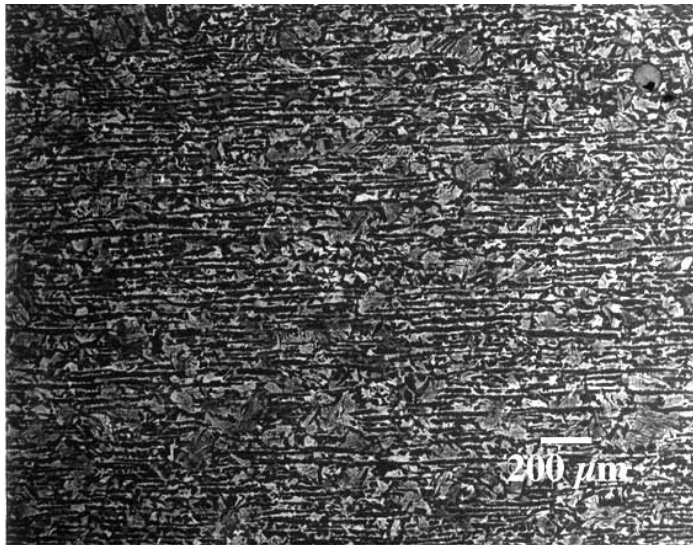
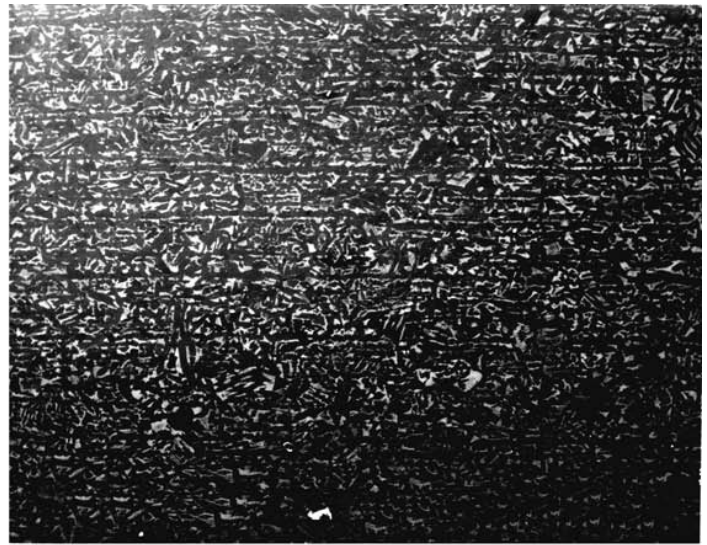
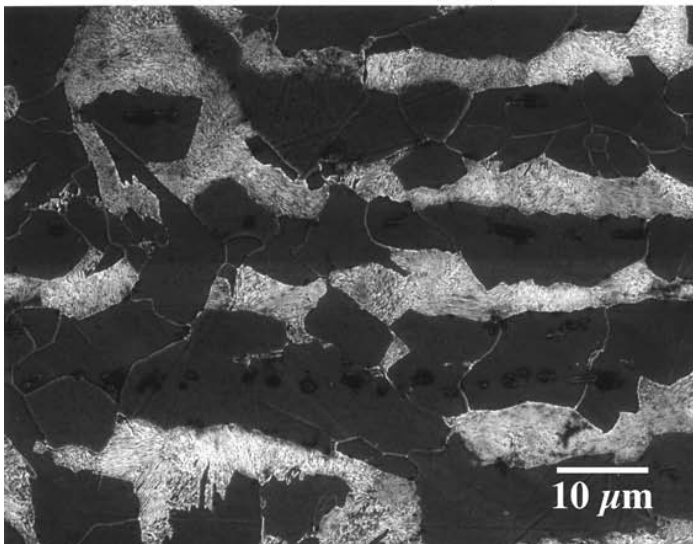
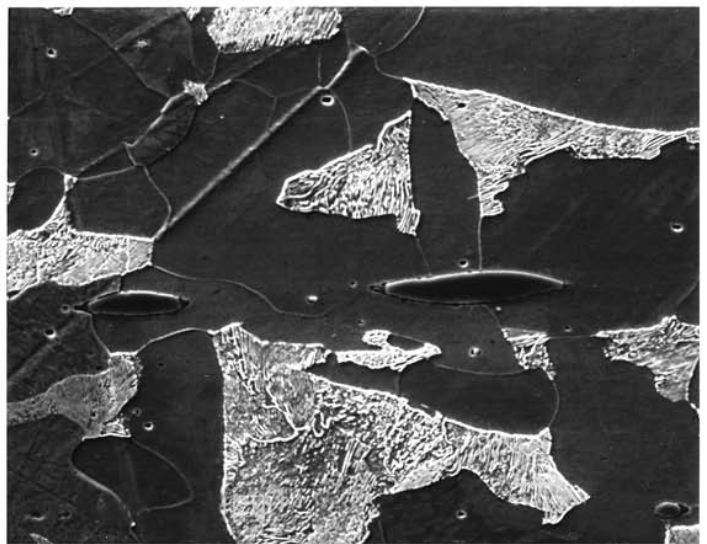
Steel samples of all three orientations orthogonal with respect to the rolling plane were polished and etched to reveal the microstructure. A ferrite-pearlite microstructure was seen, with large ferrite grains (ASTM number = 4-5, 100 μm to 130 μm equivalent diameter) and large, coarse pearlite colonies (roughly 0.2 μm lamella thickness, but quite variable). The microstructure shows a large amount of banding in the rolling direction. MnS and oxide particles are evident throughout the material, and were quite large, occasionally exceeding 100 μm in length. The MnS particles were deformed into lenticular shapes instead of being melted into stringers. Given the lack of rare-earth additions to increase the sulfide melting point (see table 2), this indicates a low rolling temperature. The large grain size and coarse pearlite are consistent with air-cooling of the rolled

A comparable modern steel grade is AISI 1018, which has a similar chemistry and does not possess a specialized microstructure. Micrographs of a modern 1018 steel show a finer grain size, much finer pearlite, and smaller and less numerous rare-earth doped MnS particles. This microstructure is typical of that produced in a modern high-speed mill, followed by a quench and normalization treatment.

Figure 1: Scanning electron microscope image of the polished and etched longitudinal sections of steel from the hull of the *Titanic*, and for comparison a modern hot-rolled 25 mm (1") AISI 1018 plate. Note the differences in grain size, pearlite lamella spacing, and MnS particle sizes.

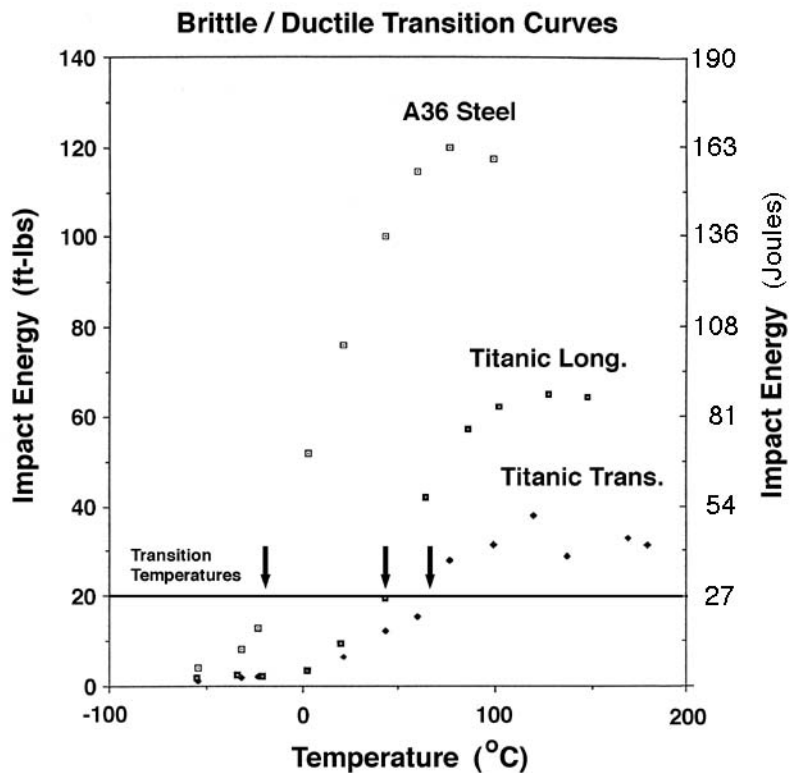
The data produced from tensile tests performed on steel recovered in 1996 [5] and 1991 [2] is shown in Table 1. The uncertainty in this data is unknown. These values are consistent with the design requirements of “15-20 tonnes per inch squared” as specified by Harland and Wolff (the shipbuilder who constructed *Titanic* in Belfast in 1911 [4]). Two groups of Charpy specimens were prepared such that in one group the long direction of the specimens were parallel to the longitudinal direction of the hull plate (LS) and in the second group the long axis of the specimen was parallel to the transverse direction (TL). The adjoining figure compares the experimental results from the Charpy impact test of the *Titanic* hull steel for the longitudinal and transverse rolling directions with a modern ASTM A36 mild steel [7]. Unfortunately for the purposes of a direct correlation of properties and microstructure, the comparison of mechanical behavior was made versus A36 steel, which is chemically nearly identical to AISI 1018 used in the microstructural comparison, but has a more specialized microstructure. Using 20 ft-pounds (27 J.) for the determination of the ductile-brittle transition temperature, the author [5] obtains a transition temperature of -15°C for the modern A36 steel, while the *Titanic* specimens yielded transition temperatures of $+40^{\circ}\text{C}$ for specimens in the longitudinal direction and $+70^{\circ}\text{C}$ for the transverse direction. The transition temperatures for the *Titanic* steel are much above the water temperature of -2°C at the time of the ship-iceberg collision [1].

Figure 2: A plot of the impact energy measured by the Charpy test versus temperature for two different orientations for the *Titanic* hull steel, as well as modern A36 (which is chemically and microstructurally very similar to AISI 1018). The transition temperature is marked for each series of samples, and is defined as that temperature where the sample exhibited 20 ft-lbs (27 J.) of energy. Data from reference [5]. The uncertainty in the data is unknown.

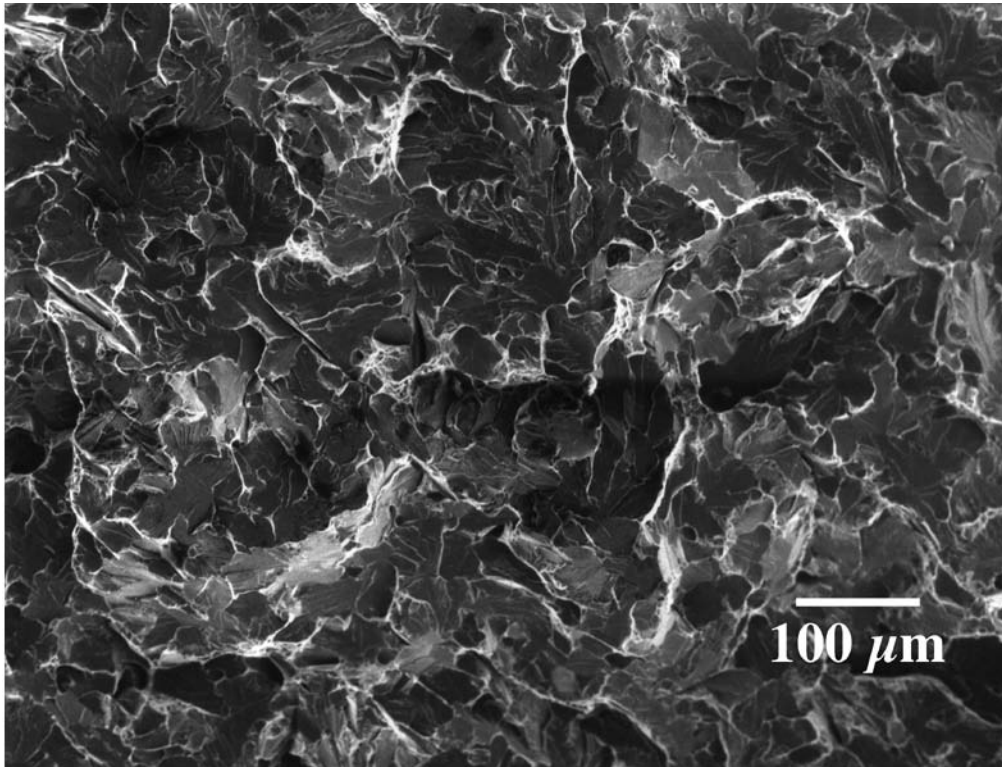
Fracture surfaces cut from the Charpy test specimens tested from the 1996 plate were examined in the scanning electron microscope. Fracture was entirely transgranular (figure 3), with no evidence of fractured grain boundaries. This is significant, in that if the cause of limited fracture ductility of the steel (as evidenced by the absence of microvoids) had been sulfur embrittlement, we would expect sulfur segregation to the grain boundaries and intergranular fracture facets. At ice-brine temperatures, the fracture was nearly entirely brittle, with the ductile portion of the fracture surface estimated to be less than 5 percent (figure 4). Cleavage patches on the surface, made up of 4 to 15 cleaved grains, were seen to originate at fractured MnS particles, as evidenced by tracing river lines on the facets. This indicates that in some cases the MnS particles acted as initiators, but the incidence of these nucleated patches amounted to less than 10% of the surface area of the Charpy bar fracture surface.

Figure 3: SEM fractograph of Charpy bar fracture surface (LT) from a sample fractured at 0° C. Note the presence of cleavage facets and absence of fracture grain boundaries. One or two cleavage patches nucleated by MnS particles can be identified in this image.

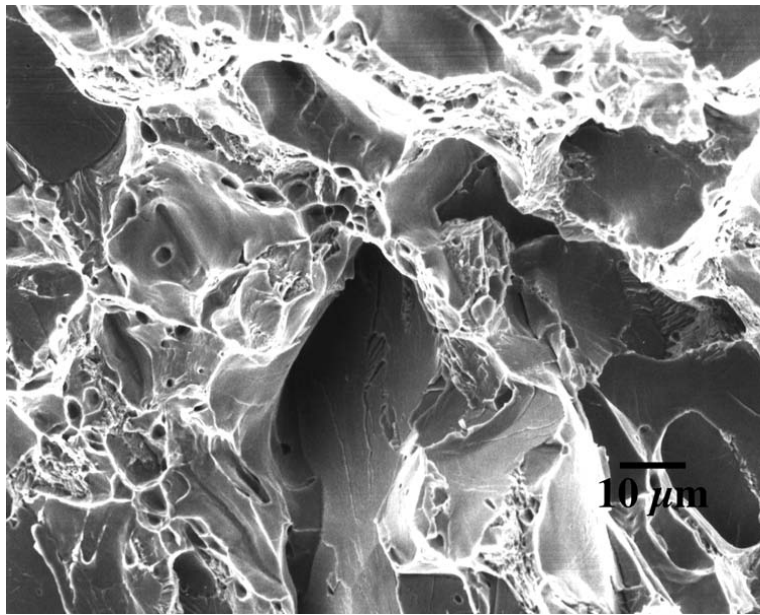
Figure 4: SEM fractograph of Charpy bar fracture surface from a sample fractured at 0° C. Note presence of ductility along ridges. This micrograph contains the largest amount of plasticity observable on the surface in one area of the fracture surface of this sample.

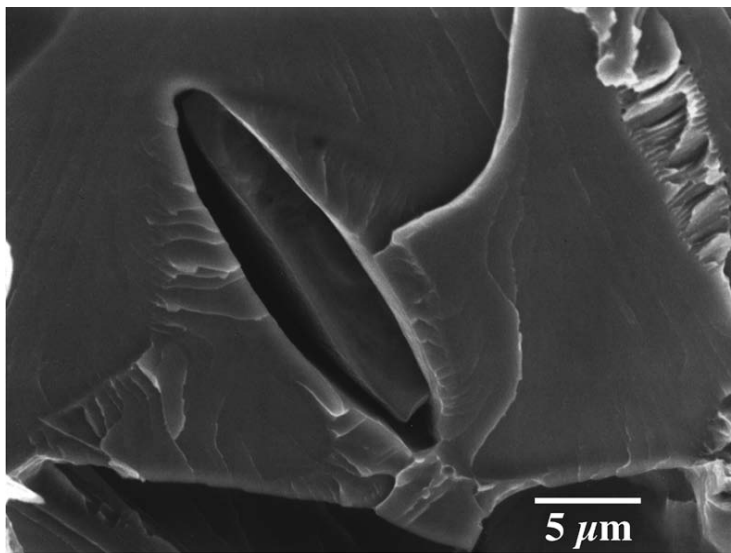
Figure 5: SEM fractograph showing the MnS particle that fractured and nucleated a patch of 15 cleaved grains. This was determined by tracing river lines within the patch. Note the lenticular shape of the particle, the cleavage river lines emanating from the particle, and the fractured course pearlite colony in the upper right corner.

The presence and large size of the MnS particles are considered deleterious to fracture resistance, as they act as crack initiators within the steel at temperatures near the lower shelf [19]. It was seen that the plate recovered in 1996 exhibited 5% ductile fracture during Charpy tests at ice-brine temperatures, and that MnS particles, upon examination of the fracture surface, nucleated a few patches of cleavage. However, the plate recovered in 1991 was 100% brittle even at room temperature [20], placing it firmly in, not near the lower shelf regime. Thus MnS particles would have little to no effect on toughness in this plate. The presence of MnS particles and their effect on crack growth have been found to be much more important at high temperatures than lower temperatures. Their effect on the fracture behavior of both the material in this study as well as the 1991 study [2] are considered negligible. Although cleavage patches have been identified on the fracture surface as having come from the fracture of a MnS particle, and thus the formation of a process-zone would have begun, the occurrence of this was relatively rare. It is believed that the fracture mechanism that controlled at -2°C would have been weakest-link [18], where the first fractured microstructural feature would have precipitated failure. And as the population of large carbides, in the form of thick pearlite lamella, is many times that of large sulfides, it is more likely that a fractured carbide would precipitate failure.

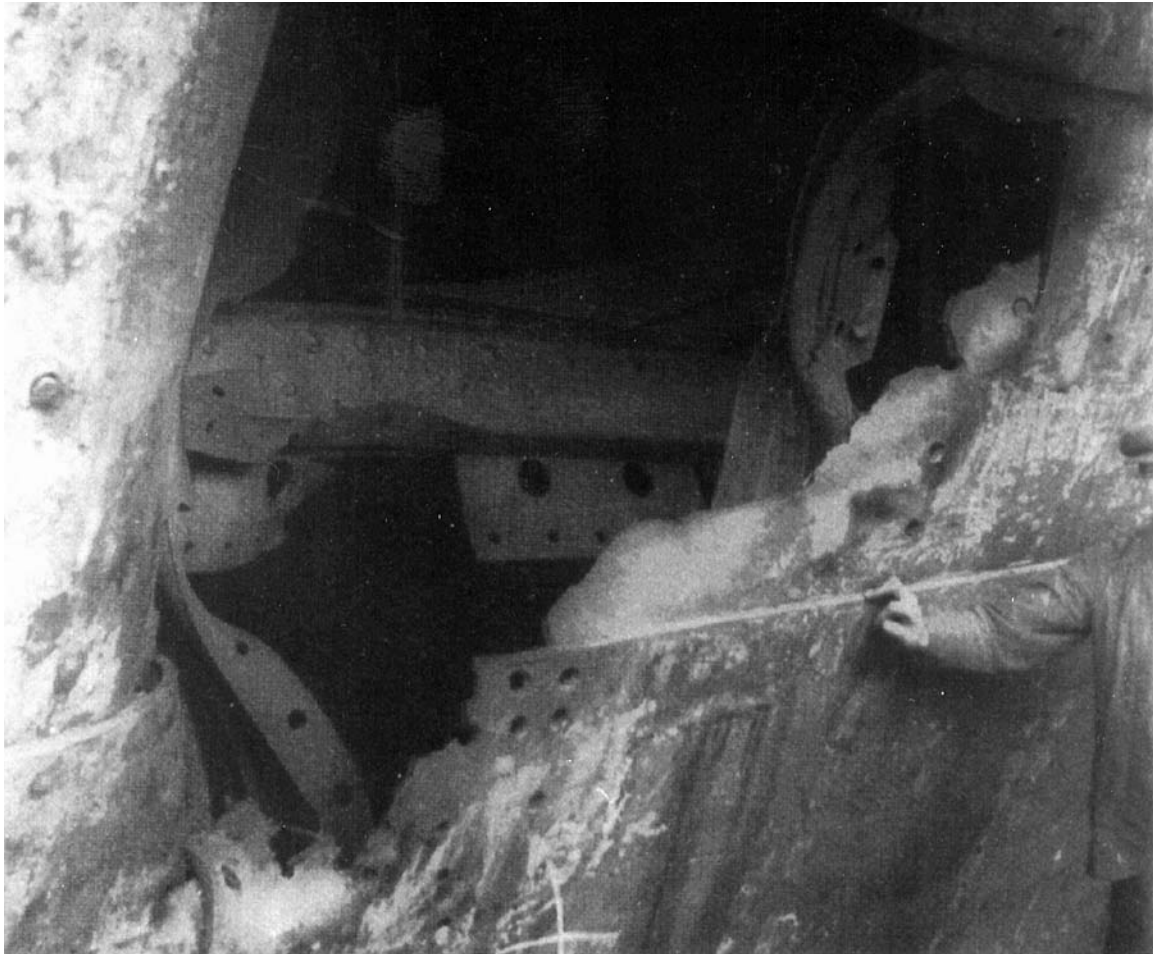
Figure 6: A close-up of the damage to the *RMS Olympic* due to collision with the *HMS Hawke* in the Solent in 1911. Note the man for scale. A considerable amount of plasticity in the hull plates is indicated by the bending and twisting seen in the picture. Note missing rivets. Photo from [25].

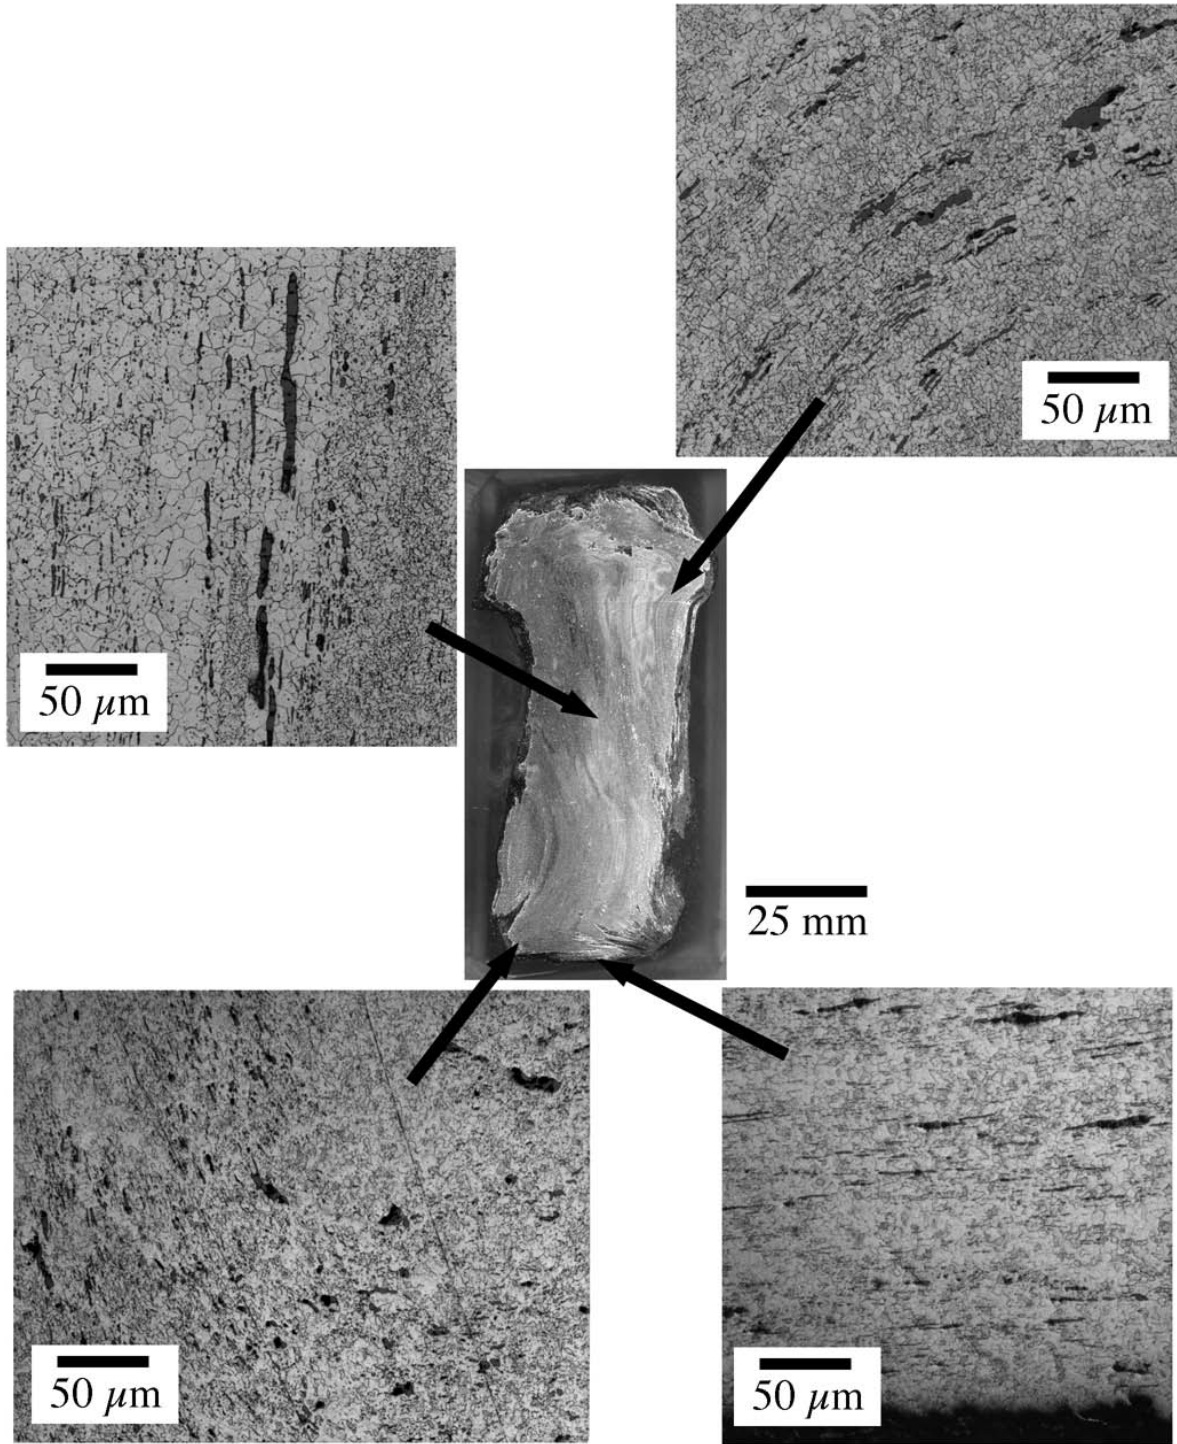
The two hull rivets in possession have been sectioned and examined. Both exhibit the above-mentioned orientation distribution of slag stringers within the rivet, an increased amount of incorporated slag, and are both missing the inner head. These metallurgical factors would have degraded the mechanical performance of the rivet. If additional samples are obtained during an expedition planned for August of 1998, further work will be performed to determine if this was a major factor in the sinking of the ship. Rivets from an intact section of a lap joint will be sectioned to see if rivets that did not fail contain elevated slag levels and transversely-oriented slag stringers. It is important to reiterate that only two rivets have been sectioned to date, out of 3,000,000, some minority percentage of which held the hull together.

Figure 7: Montage of micrographs showing the orientation of silicate slag at various locations within a cross-section of a *Titanic* hull rivet. Note that in the upper pre-formed head (formed onto a hot rod of wrought iron prior to cutting the rivet to length), the slag spreads out evenly into the head like the branches of a tree. At the bottom, where the inner head popped off, very near the fracture surface the stringers are oriented perpendicular to the tensile axis. This occurred presumably when the inner head was formed.

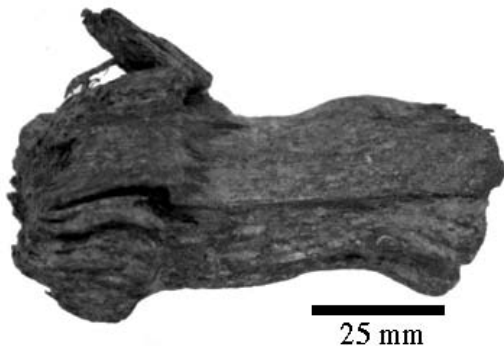
material. This represents a smaller amount of deflection of the hull plate applying the stress through leverage against the supporting rib inside the ship. High residual stresses would increase the tendency of rivets to “pop” during collisions. The presence of high residual stresses in *Titanic* rivets can be seen in a badly-corroded bulkhead rivet, seen in figure 9. The head of the rivet has exfoliated and the slag stringers have spread, driven by residual stress during stress corrosion cracking and dissolution of the ferrite.

Figure 9: Bulkhead rivet from RMS Titanic. Note the portion of the head that exfoliated during corrosion of the ferrite matrix of the wrought iron, under the influence of the residual stress in the rivet.
